Zamperla Inc.

Maintenance Bulletin

Re: Rio Grande Train Possible Shock Hazard

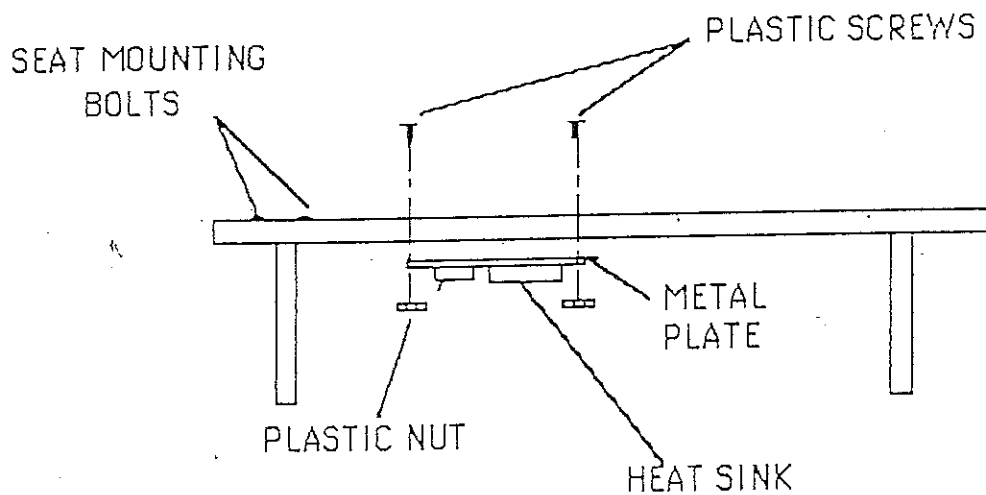
A Rio Grande train manufactured during 1992 has been found to have metal plates substituted for the bakelite plates that attach the circuit breaker and heat sink under the seat of each car. These plates are attached with metal carriage type bolts. During assembly no insulation was provided. This creates a 24vdc potential between the 2 bolts that mount the plate and the remainder of the seat bolts. We are asking all Rio Grande owners to inspect this area of their ride to determine if the plates are Bakelite or Metal, and if the plates are metal to look for insulating bushings surrounding the bolts. If the plates are metal and there are no insulating bushings please contact our Service Department to receive the following modification parts free of charge to correct the condition. If Bakelite plates or metal plates with bushings are present there is no need to replace the mounting bolts.
