## SERVICE BULLETIN

Ride Manufacturer: A. Zamperla SpA	Affected Production Dates: 2004 and after
Ride Name: Twister Coaster Family	Affected Serial Nos.: All
Model Number: 420M, 310M, JUNIOR

Certain maintenance procedures have been modified

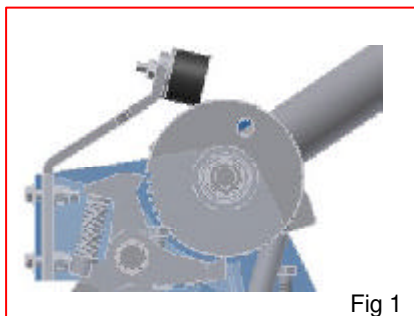
- 1\_ open the individual T-bars (with the key)
- 2\_ put the individual T-bar in the "max opening" position (Fig. 1) and pull the individual T-bar in the opening sense.
- 3\_ make the same procedure by putting the individual T-bar in the intermediate position (Fig. 2) and in the "all close" position (Fig. 3)

If the individual T-bar do not stay correctly closed, it is FORBIDDEN for passengers to get into the ride and you must repair the individual T-bar.
