# Zamperla Inc.

## Maintenance Bulletin

RE: Freeze Damage Mini-Jet Center

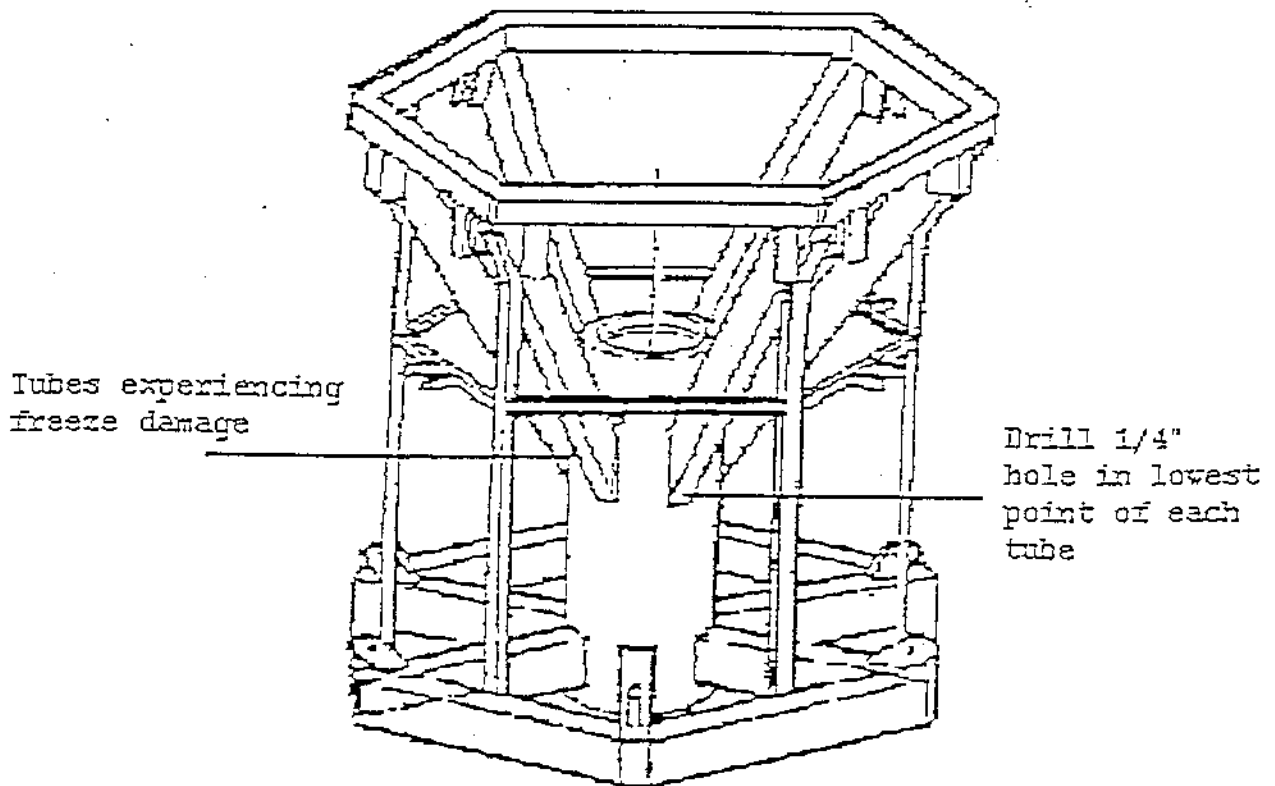
Several Mini-Jet centers have experienced freeze damage when water has collected in the vertical rectangular tubing and frozen. Please inspect your Mini-Jet center piece for this condition. If your ride doesn't have weep holes in this area drill a 1/4" hole as shown in each rectangular tube. If there is damage to the tubing, the only recommended repair is replacement of the tube. There is no danger from swelling of the tube as long as there is no cracking present. Swollen tubes should be replaced as soon as possible, (do not attempt to heat and straighten swollen tubes) cracked tubing must be replaced before operating the ride.
